## **CASE REPORT:**

This case highlights the use of Friction Management Techniques using ShearBan® Friction Relief Patches.

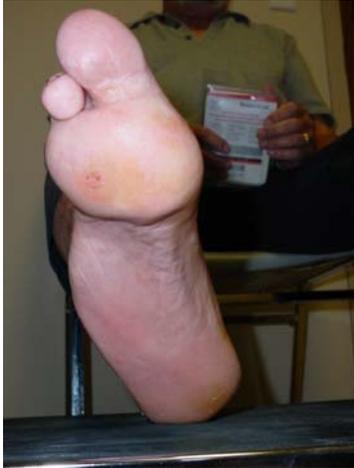
Right foot at 1<sup>st</sup> consultation

For orthotic management of Mr. X, I recommended depth inlay shoes (with extended steel shanks and forefoot/hindfoot rocker soles), custom multi-density accommodative inserts (1/2" blue puff, PPT, and pink plastizote using usual pressure management designs/techniques), and local friction management using ShearBan<sup>®</sup> applied to the areas of plantar ulceration and high pressure.

In addition to the usual pressure management techniques, shoe fit and modifications, ShearBan<sup>®</sup> was applied to the areas of plantar ulceration and high pressure on the accommodative inserts. The patch of ShearBan<sup>®</sup> material was heat/vacuum inlayed into the insert.

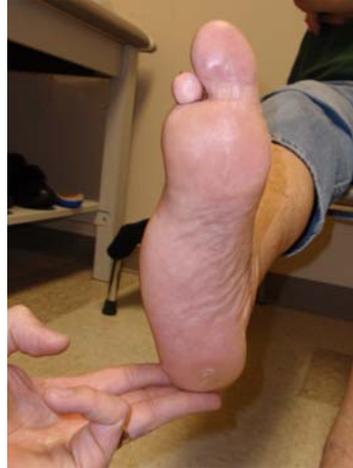
After 11 weeks of treatment

\*Note: Area beneath the calcaneus appears to be callusing, but is actually dermatitis. This is not a pressure/shear situation.

Mr. X was seen for follow-up of orthotic management every two weeks after the initial visit, and remained compliant wearing his shoes and inserts full time. Over the course of 11 weeks of treatment (6 office visits) the ulcer healed completely, and as of this writing, he remains ulcer-free for an additional 20 weeks.

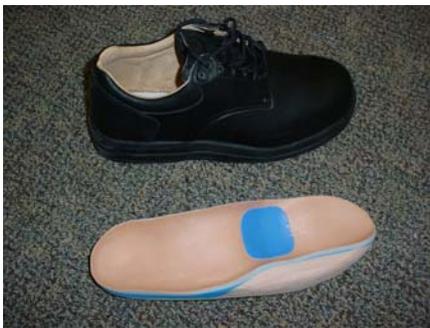
Devices provided for right foot

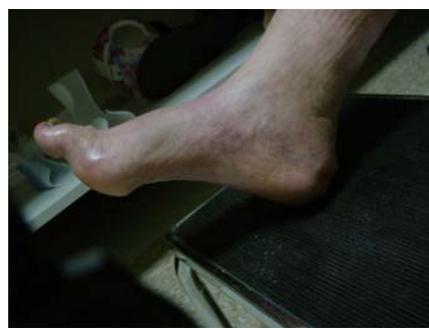
Sagittal view of right foot  
(rigid deformity)

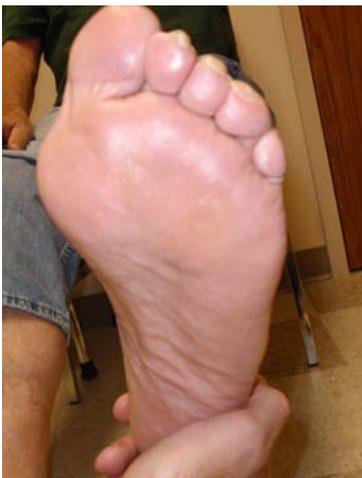
Left foot at treatment onset

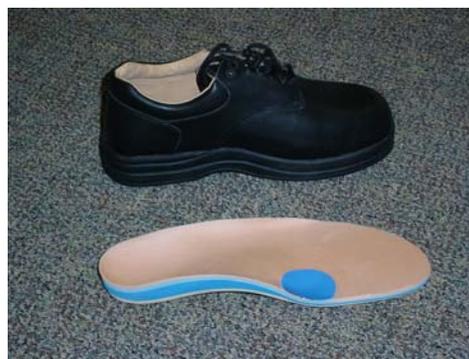
Devices provided for left foot
